New York State Department of Transportation

Yellow Flag NB2228W008

Flag Date: March 18, 2022

BIN: 1065318

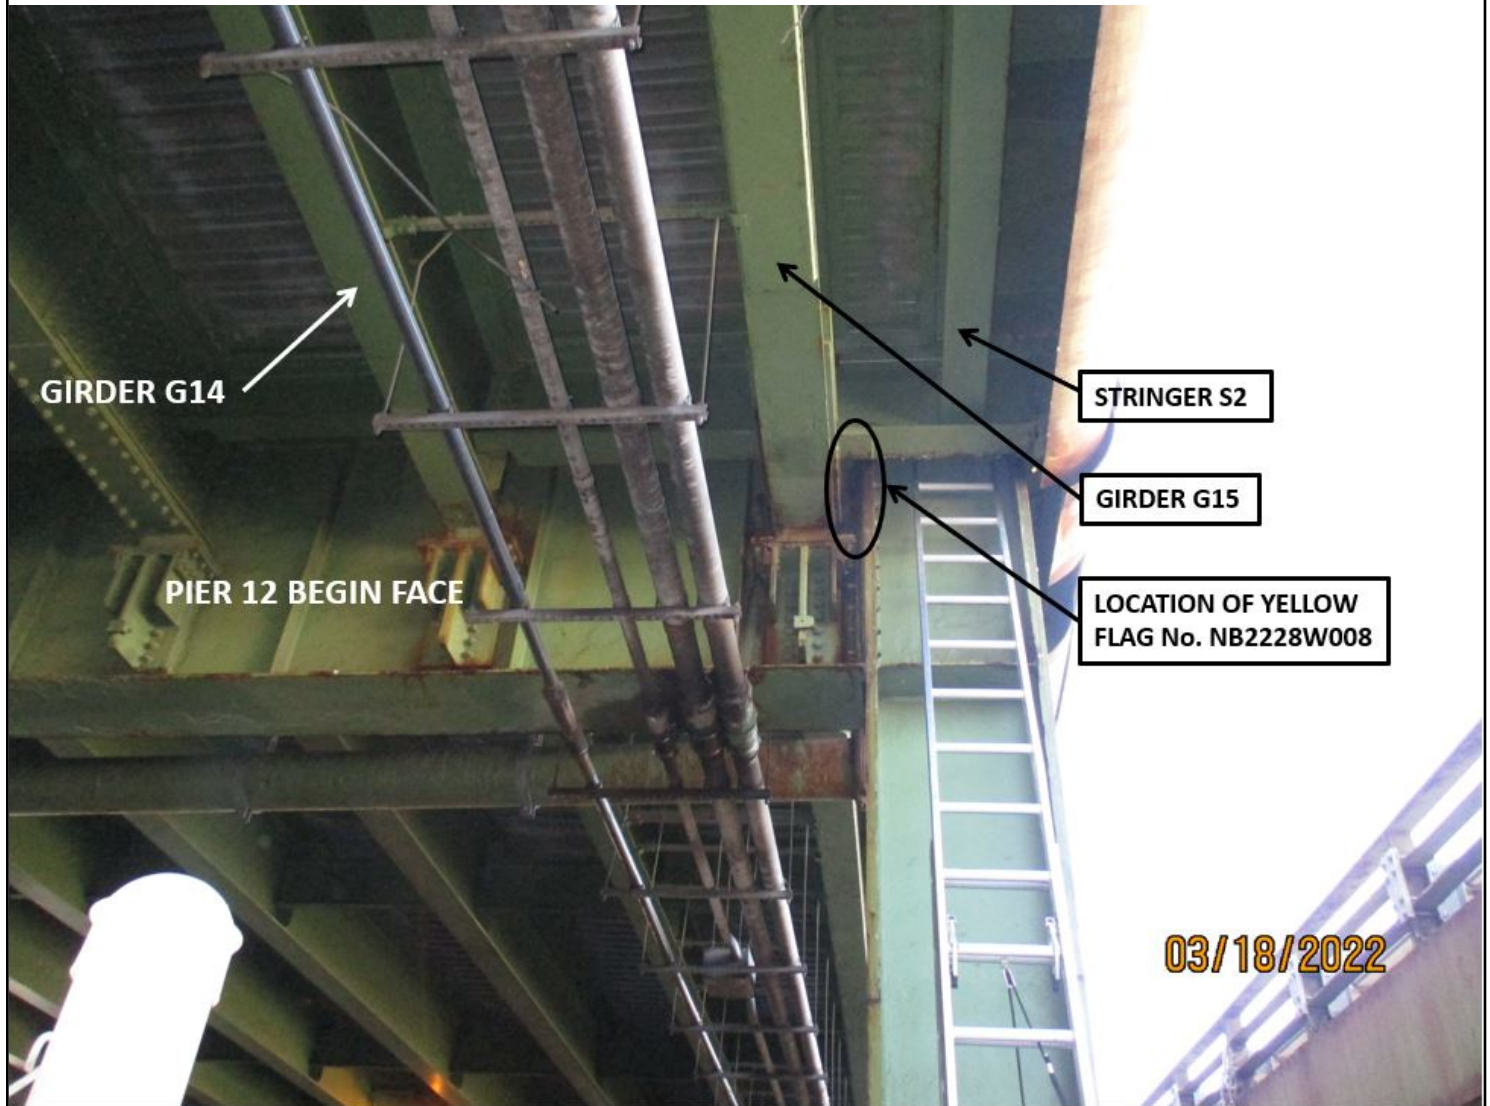
Photo Number: 1

Attachment Description: Span 12 G15 at Pier 12, Looking End: General view of the flagged location that exhibits a curved crack 6" long in the web at the top cope at the connection to Pier 12 Capbeam with an adjacent 3"H x 1/4"W corrosion hole with a 1" long vertical crack at the top of the hole and a 3" long vertical crack at the bottom of the hole.

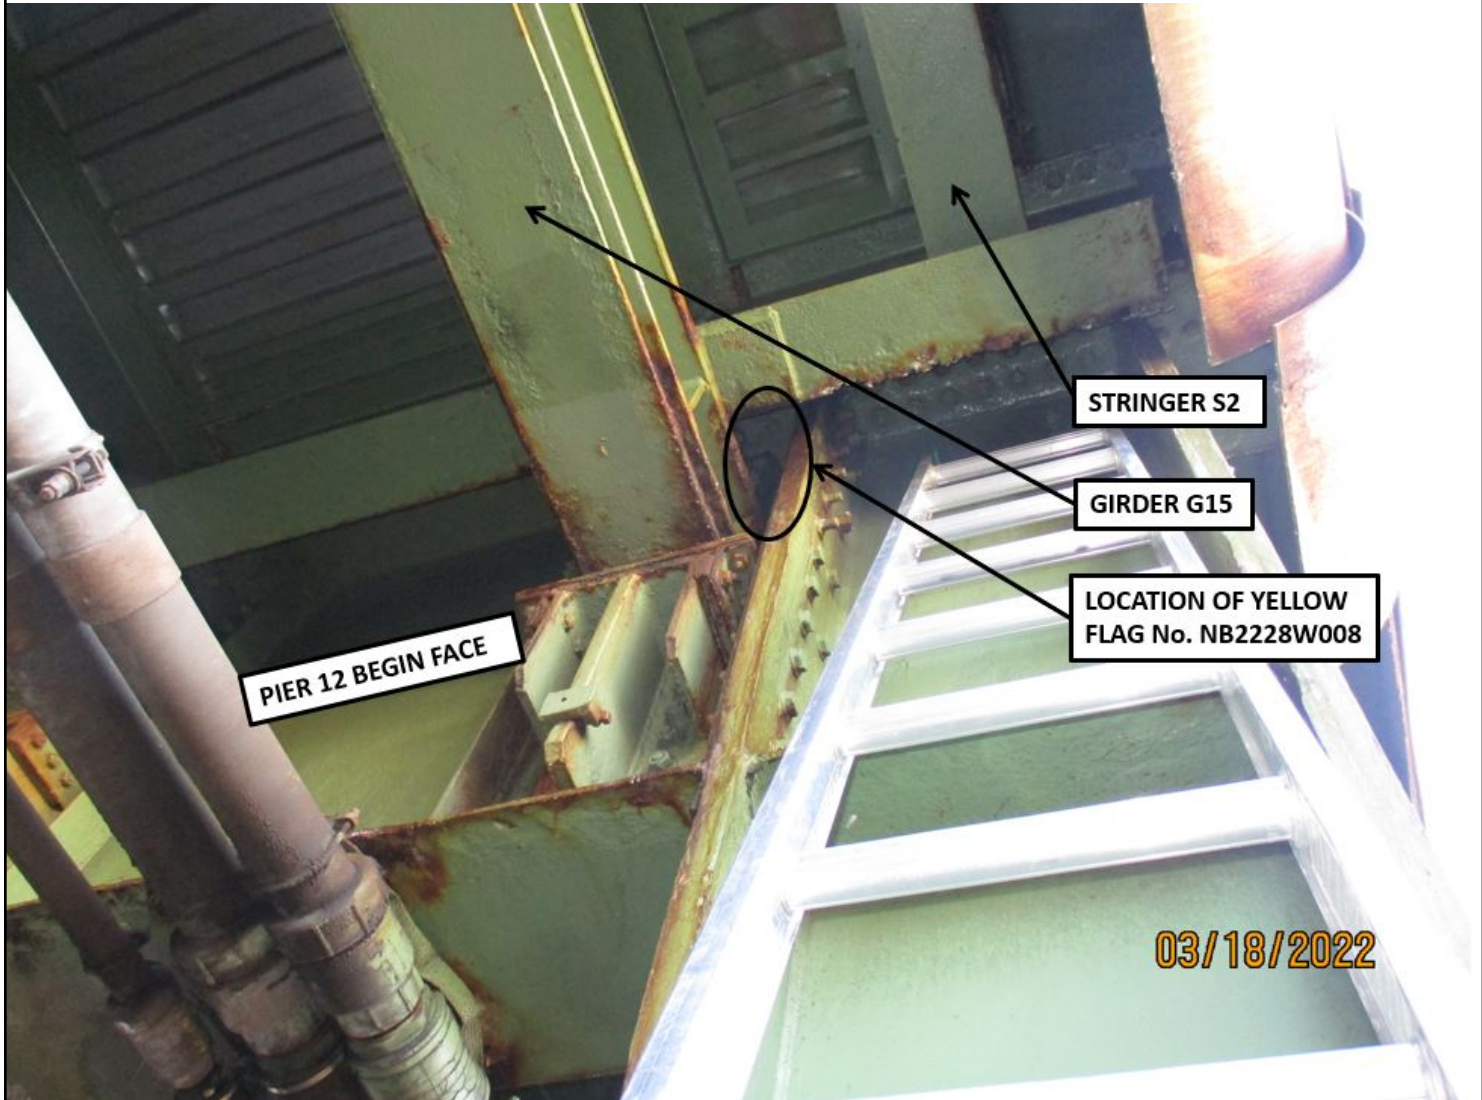
Photo Number: 2

Description: Girder G15 exhibits a 6" long curved crack in the web of the girder at the top cope, at the connection to the Pier 12 Capbeam (no change from the previous inspection). Adjacent to this curved crack, also in the girder web, there is a 3"H x 1/4"W corrosion hole with a 1" long vertical crack at the top of the hole and a 3" long vertical crack at the bottom of the hole (Photo 4). The cracks and the hole are in an area of 30 to 70% Section Loss around the top cope. A Dye Penetrant test could not be performed due to the tight access to the area (Photo 2).

Attachment Description: Span 12 G15 at Pier 12, Looking End-Left: General view of the flagged location that exhibits a curved crack 6" long in the web at the top cope at the connection to Pier 12 Capbeam with an adjacent 3"H x 1/4"W corrosion hole with a 1" long vertical crack at the top of the hole and a 3" long vertical crack at the bottom of the hole .

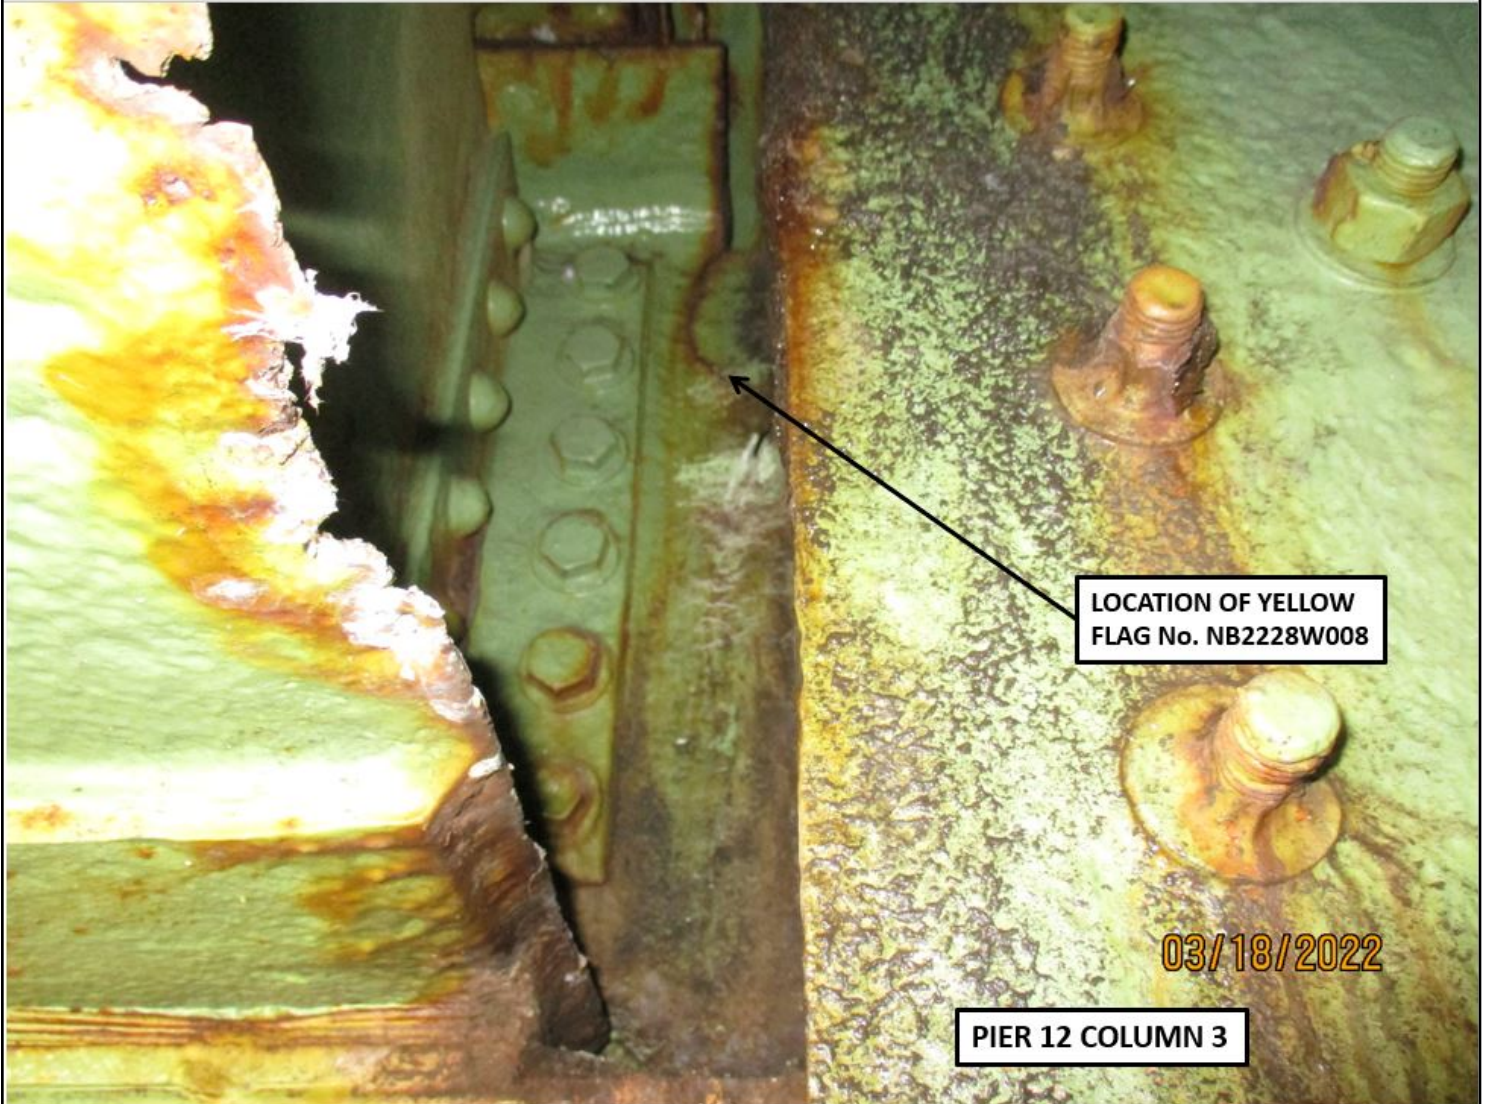
Photo Number: 3

Attachment Description: Span 12 G15 at Pier 12, Looking Left: Close-up view showing the right side of the Girder G15, that exhibits a curved crack 6" long in the web at the top cope at the connection to Pier 12 Capbeam with an adjacent 3"H x 1/4"W corrosion hole with a 1" long vertical crack at the top of the hole and a 3" long vertical crack at the bottom of the hole.

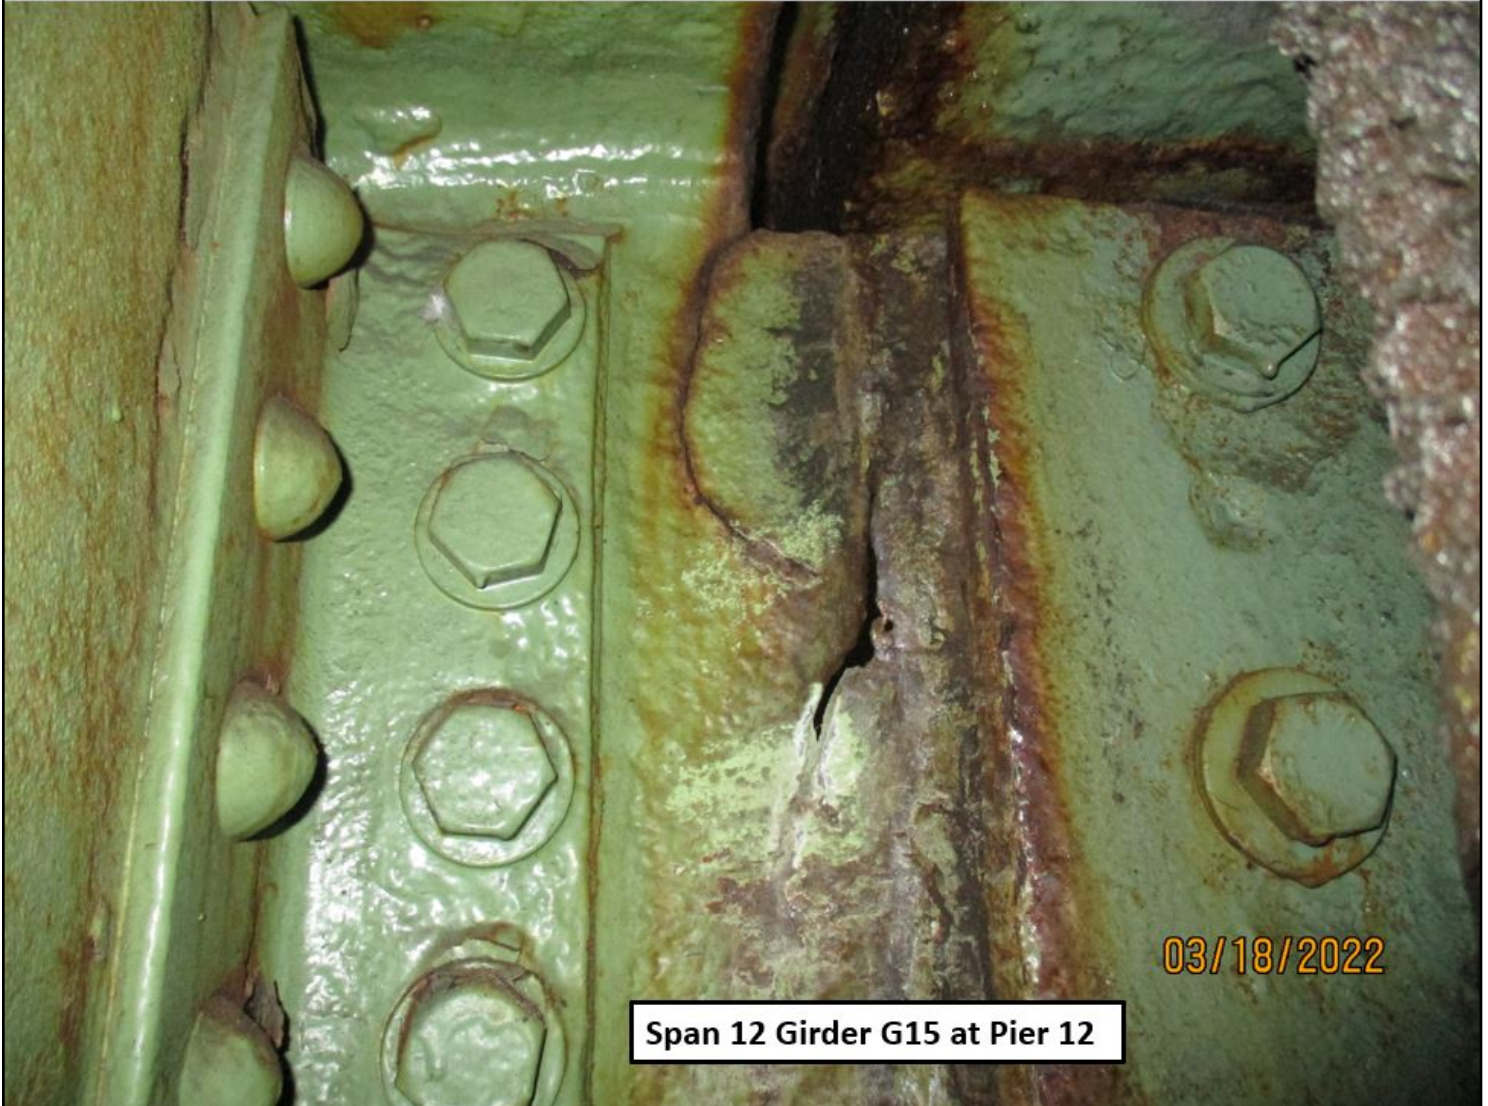
Photo Number: 4

Attachment Description: Span 12 G15 at Pier 12, Looking Left: Close-up a curved crack 6" long in the web at the top cope at the connection to Pier 12 Capbeam with an adjacent 3"H x 1/4"W corrosion hole with a 1" long vertical crack at the top of the hole and a 3" long vertical crack at the bottom of the hole.

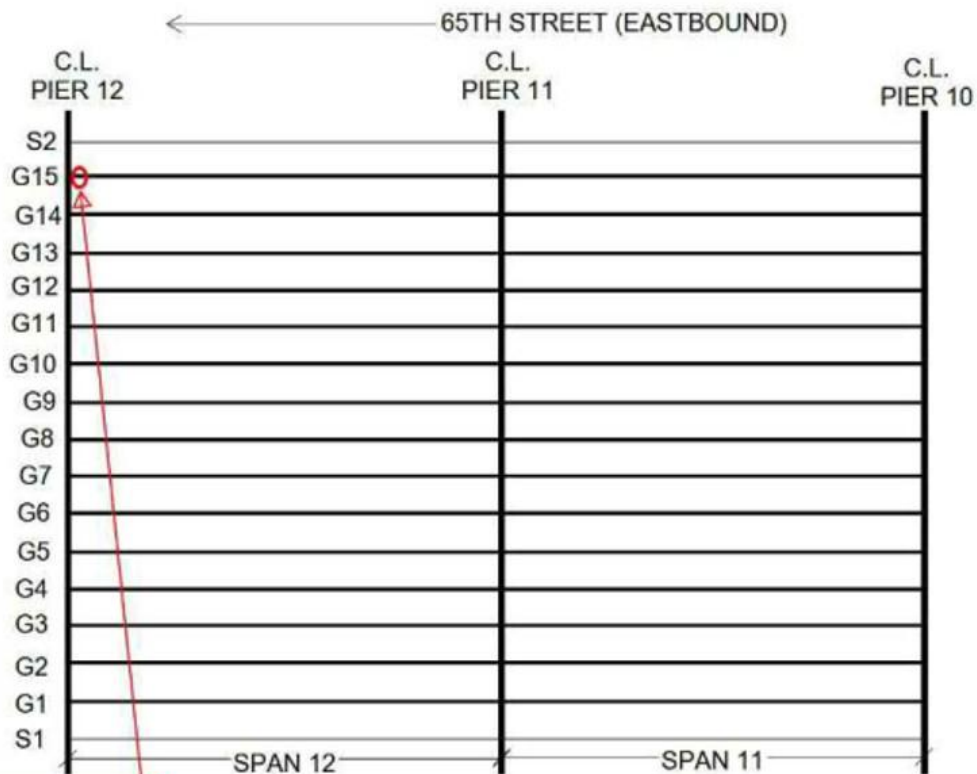
Photo Number: 5

Location: Span 12, Girder G15 at Pier 12,

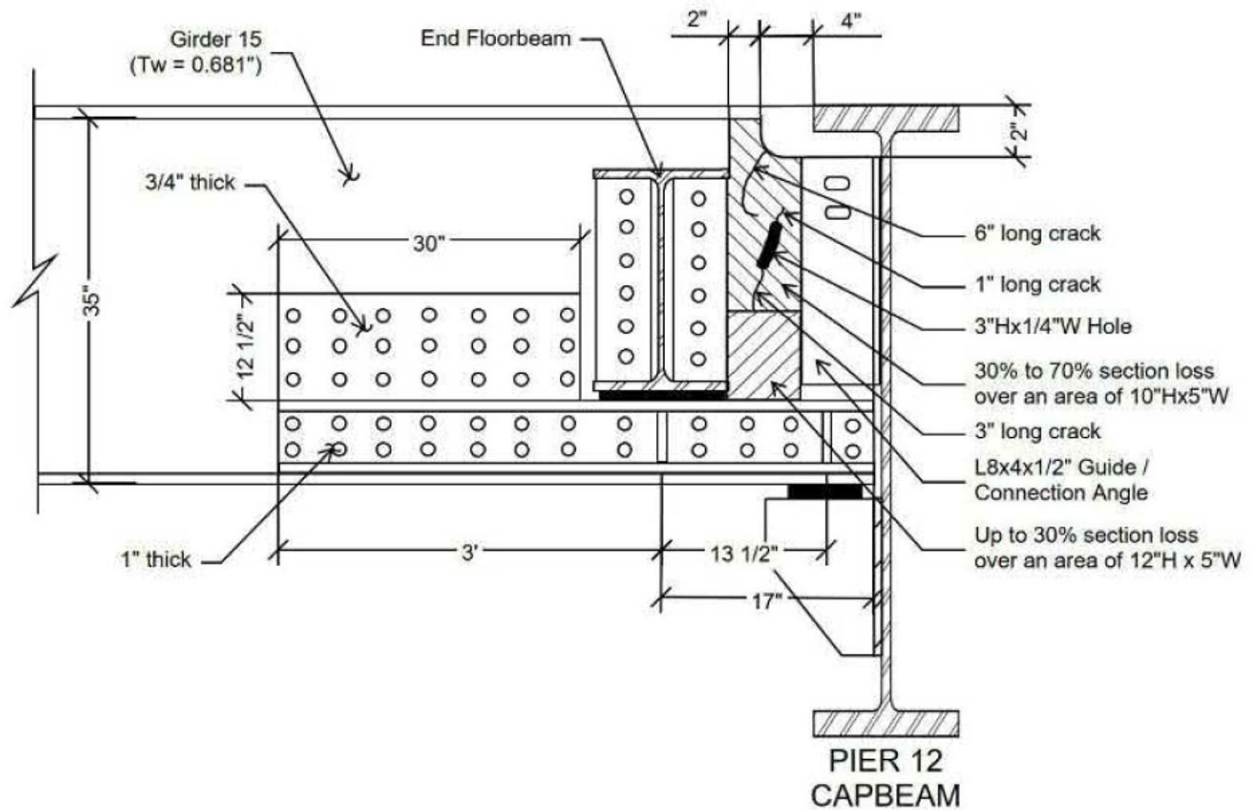
SPAN 12, GIRDER 15 BEAM END AT PIER 12
(LOOKING LEFT)
N.T.S

1. At the lower web of Girder G15, over the bearing, there is an existing repair consisting of a double channel bolted to the web of the girder, above the bottom flange and bearing area. This repair is acting like a cantilever beam from the end diaphragm to the bearing, however this bolted channel repair does not address the transient nature of the crack at the top cope. The existing repair at this location also includes a web strengthening plate (see Sketch).
